136 Charing Cross Road

Brief

To review the current state of 136 Charing Cross Road in order to form a technical specification which describes the unit as it currently is (not what it could be).

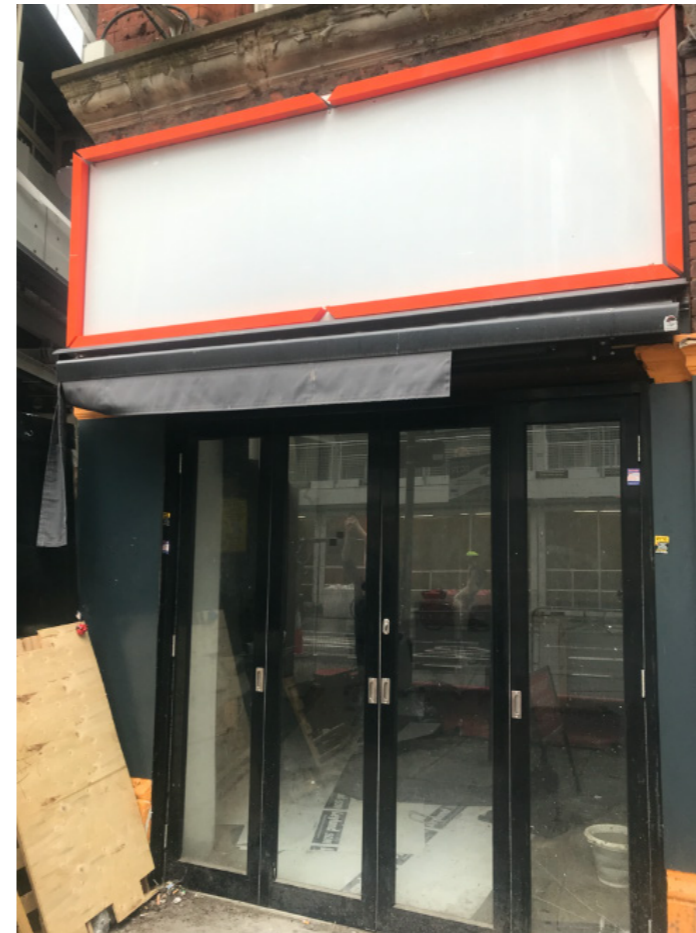
Figure 1 Front Elevation of the Vacant Unit

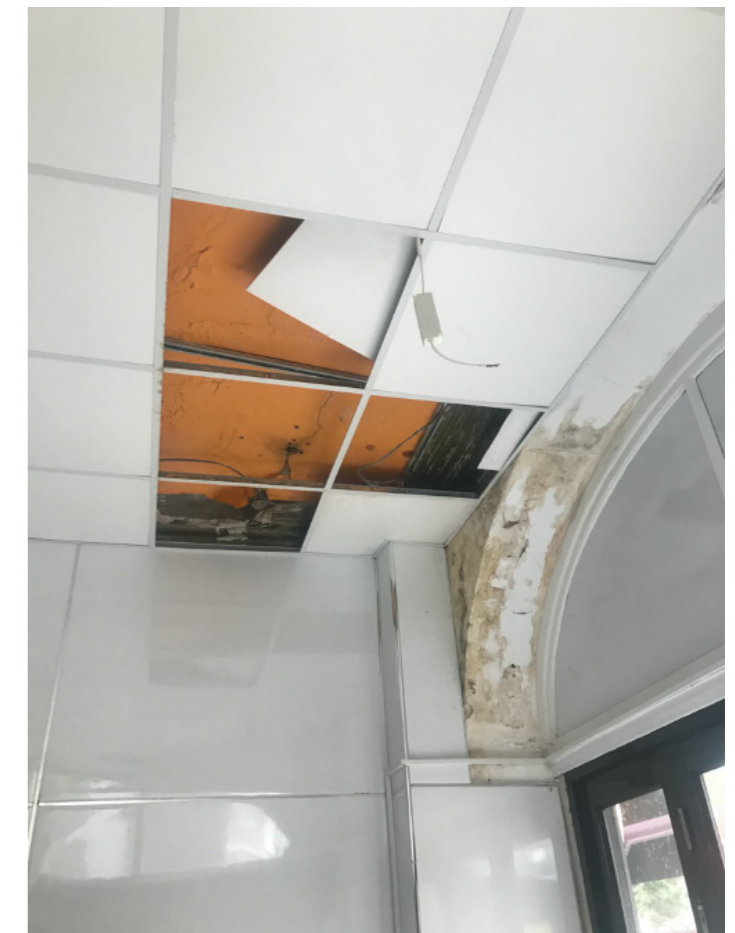
Figure 2 Internal Image of Unit
