59 St Giles High Street

Brief

To review the current condition of 59 St Giles High Street and comment upon the findings.

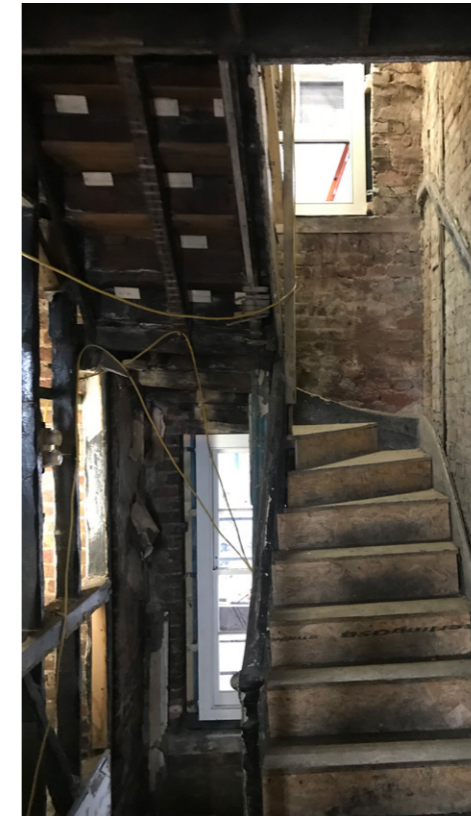
Figure 2 Internal Staircore

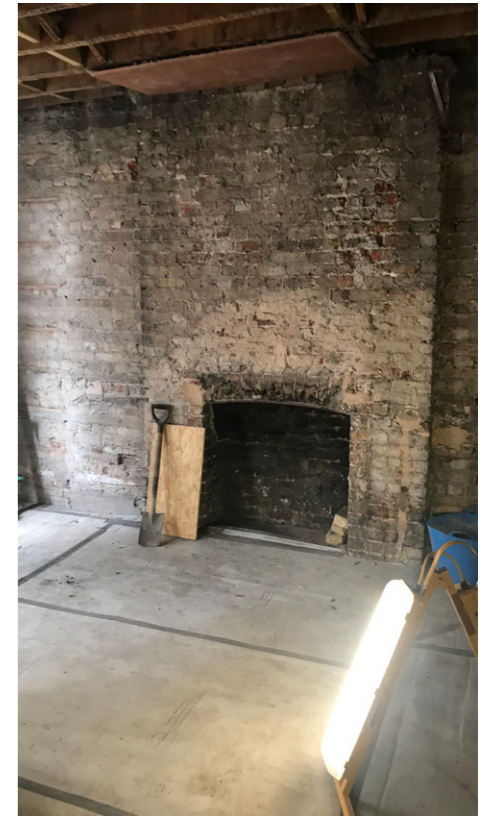
Figure 3 Internal Fireplace
